09 Plantanus Street Kuilsriver 7580	
PROJECT		LAHAE LA SARS - BLOCK B	
DWG TITLE		BROOKLYN	
DWG NUMBER		21B09-F-502-02	
DESIGNED BY		B. NOFEMELE	
CHECKED BY		H.D ROUX	
APPROVED BY		H.D ROUX	
SCALE		1:100 @ A1	
ECSA NUMBER		201070151	
ECSA NUMBER		201070151	
COPYRIGHT AND RIGHT OF REPRODUCTION OF THIS DRAWING OR ANY PORTION THEREOF IS RESERVED BY THE ENGINEERS

FIRST STOREY - EXISTING FIRE SERVICES LAYOUT (Scale 1:100)

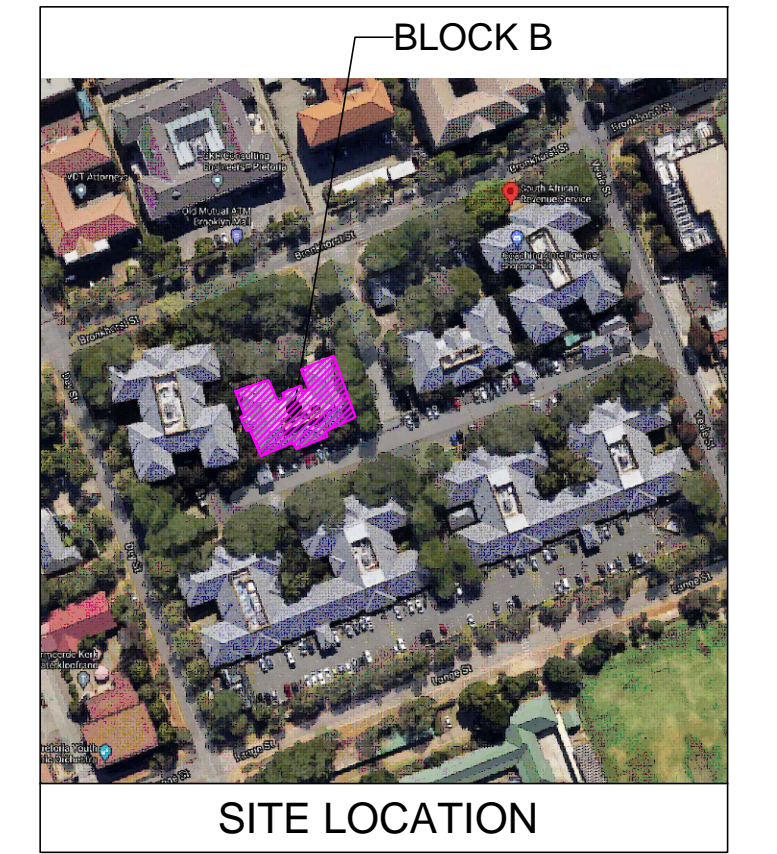
- MAJOR LIST OF NON- CONFORMANCES
1. NO HYDRANT IN BUILDING.
  2. PARTITION LAYOUT DOES NOT MATCH DRAWINGS.
  3. TURN STYLE TO RELEASE IN FIRE CONDITION.
  4. NO BREAK GLASS UNIT LOCATION SIGNS.
  5. NO DETECTION TO STORE ROOM.
  6. DIRECTIONAL SIGNAGE NEED ATTENTION FIRE EQUIPMENT & ESCAPE ROUTE.
  7. NO EXIT, KEEP CLEAR SIGN.
  8. DETECTION TO BE INTERFACED WITH THE FOLLOWING:  
5.1 AC SHUTDOWN.
  9. ROOF PLANET ROOM NEEDS FIRE PROTECTION EQUIPMENT.
